**AIRCRAFT ACCIDENT REPORT 1/2004**

**Civil Aviation Department  
Hong Kong**

**Report on the accident to  
Boeing MD11 B-150  
at Hong Kong International Airport  
on 22 August 1999**

**Hong Kong  
December 2004**

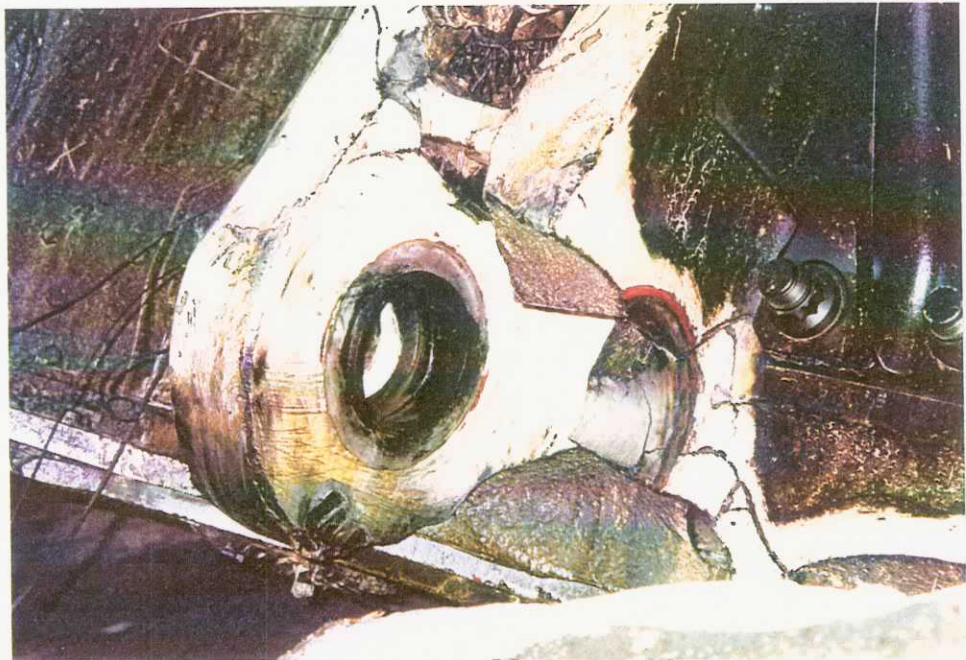
**Right Main Landing Gear (RMLG) Forward Attachment Fitting (Figure 8)**

The forward and aft main landing gear attach fitting suffered severe damage. The aft lug of the forward mount fractured between 4 o'clock to 10 o'clock position (view looking forward - see Figure 8). The fractured surface exhibited soot accumulation and slight discoloration. The forward mount was cracked and exhibited impact damage in an upward direction. The forward mount shear pin was sheared off and a portion of the shear pin remained with the forward lug (Figure 9). The remaining piece was attached to the landing gear. The fractured surface on the shear pin was heavily sooted. The aft mount was fractured, and both the lugs along with a large piece of fitting remained attached to the landing gear including the shear pin (Figure 10). The entire area of the main landing gear fitting and fractured surfaces exhibited evidence of sooting. The piece of the head-end of the main landing gear actuator remained attached to the fitting.

The right main landing gear was separated from its mount. The forward shear pin was sheared off from the forward mount and half of the shear pin remained in the forward lug of the forward mount. This section of the shear pin was pushed out and exhibited severe soot damage on the fracture surface. The remaining portion of the shear pin remained on the forward lug of the landing gear and exhibited some bending. The fractured surface on this portion exhibited surface rust and the fractured surfaces could not be examined. The aft lug of the forward mount fractured between the 4 o'clock and 10 o'clock positions. This section of the lug fractured into two pieces and was found on the runway between the touchdown point and the main wreckage. The mating fractured surface on the wing forward mount aft lug exhibited some discoloration but the mating fractured surface of the lug that was found on the runway did not exhibit any discoloration. All surfaces on the aft lug exhibited evidence of overload features. There was no evidence of fire or soot on the pieces of lug found on the runway. The forward fitting that remained attached to the landing gear fitting suffered soot damage. The forward mount fractured in the middle and exhibited impact damage in an upward direction (Figure 8).

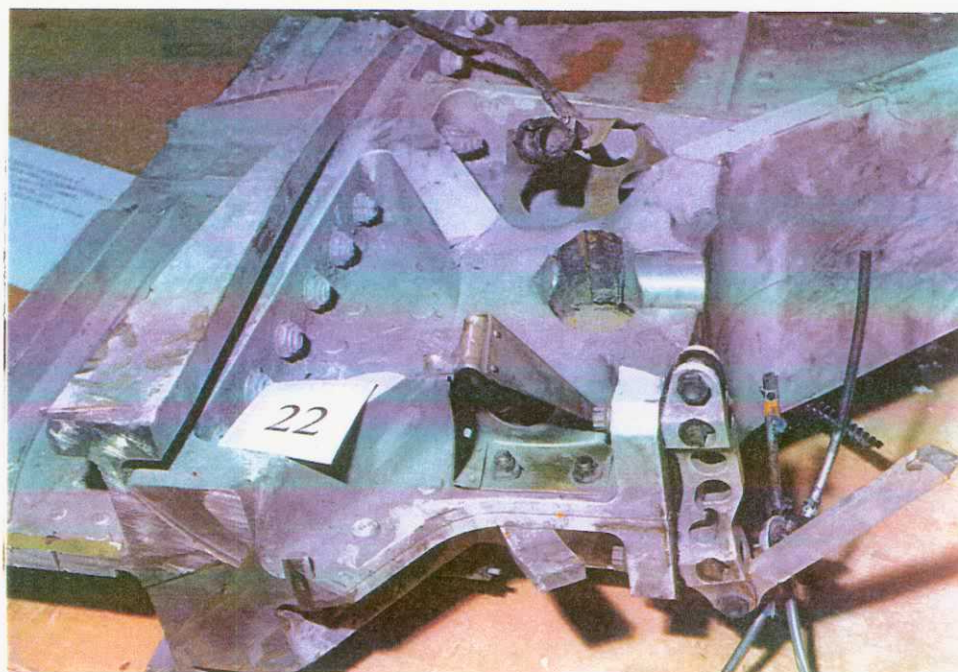
**Fractured Trapezoidal Panel (Figure 12)**

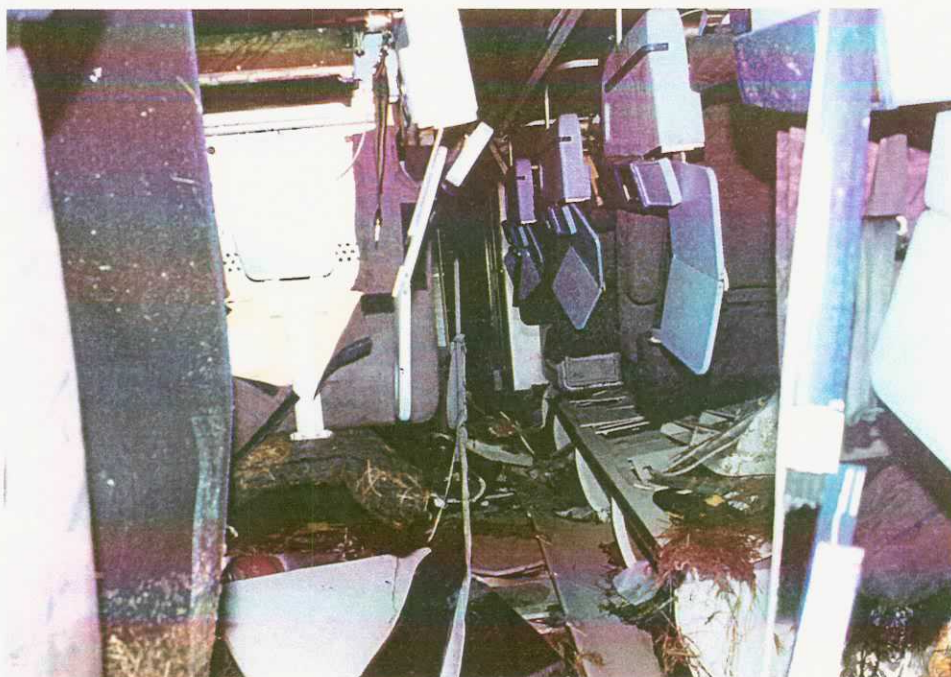
4. View of the Business Class section of the cabin.

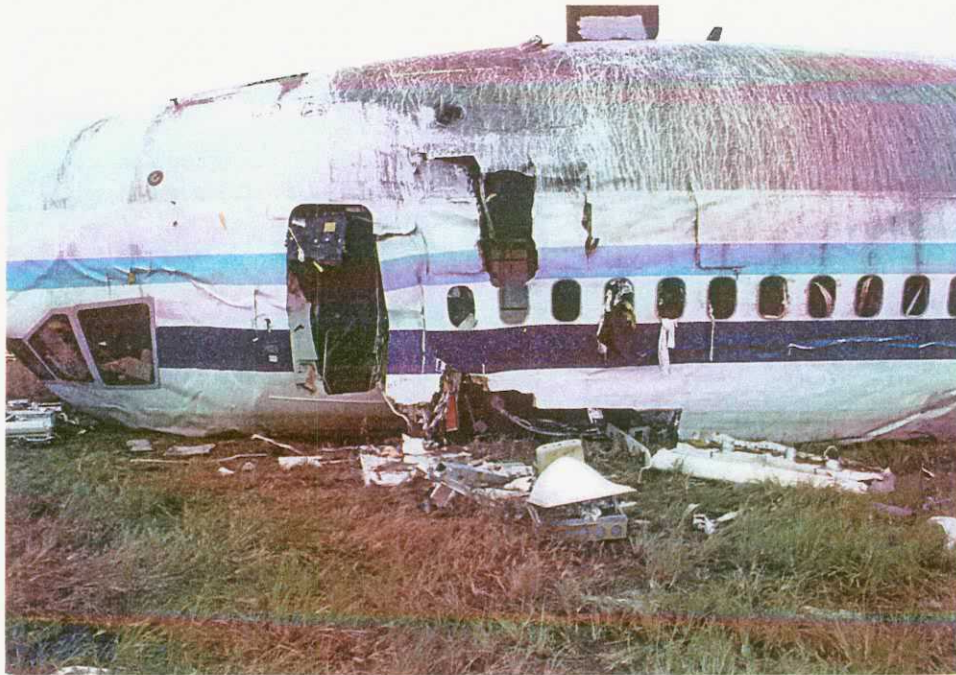
6. View of right side of fuselage including Door 1R.

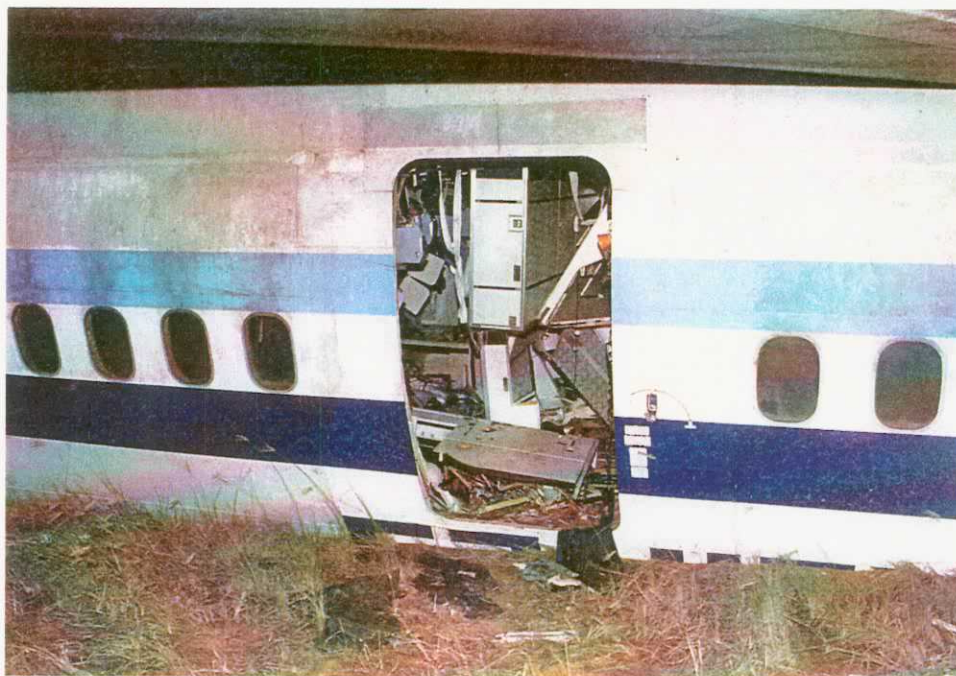
7. View of left side of fuselage including Door 3L.

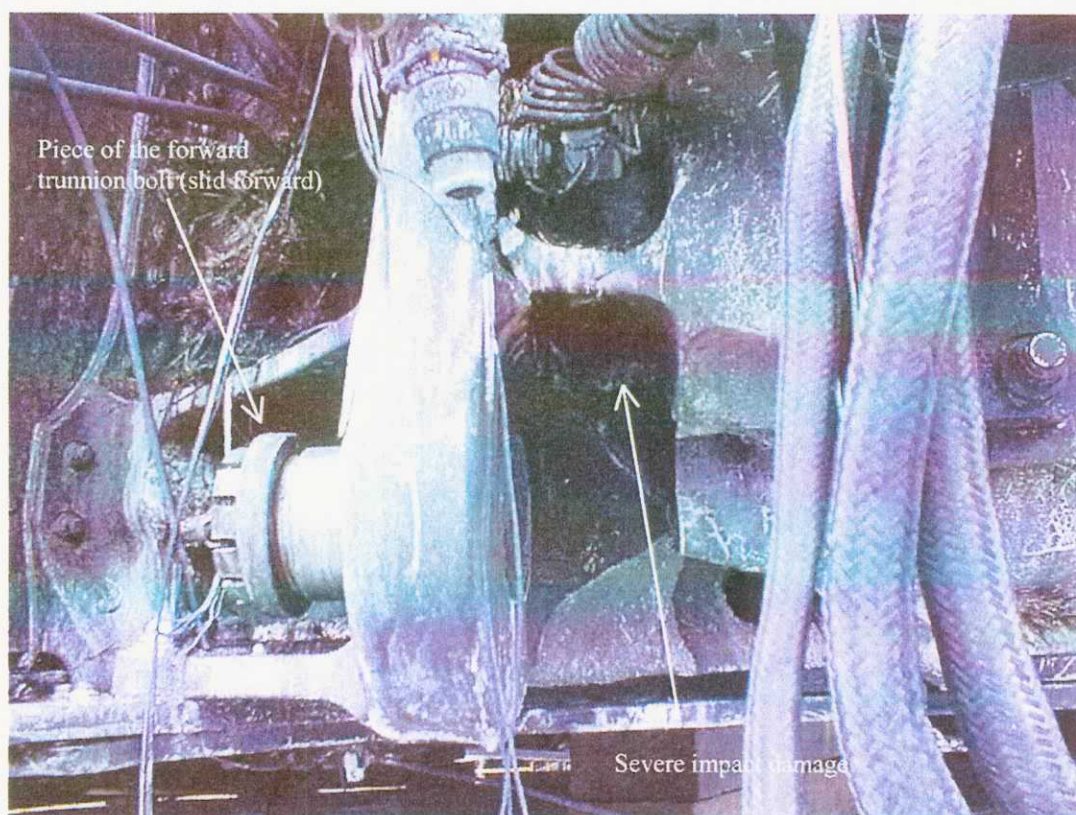
After shearing the forward trunnion bolt at the forward zero-margin groove, the forward trunnion of the right main landing gear was driven upwards and contacted the wing attach fitting, damaging the fitting. This is clearly evident in a photograph taken at the crash site (Figure 6) and in Figures 34 and 35 of the Materials and Process Engineering Report (Reference 2).

Figure 6. Damage to MLG-to-Wing Attach Fitting at the forward lugs

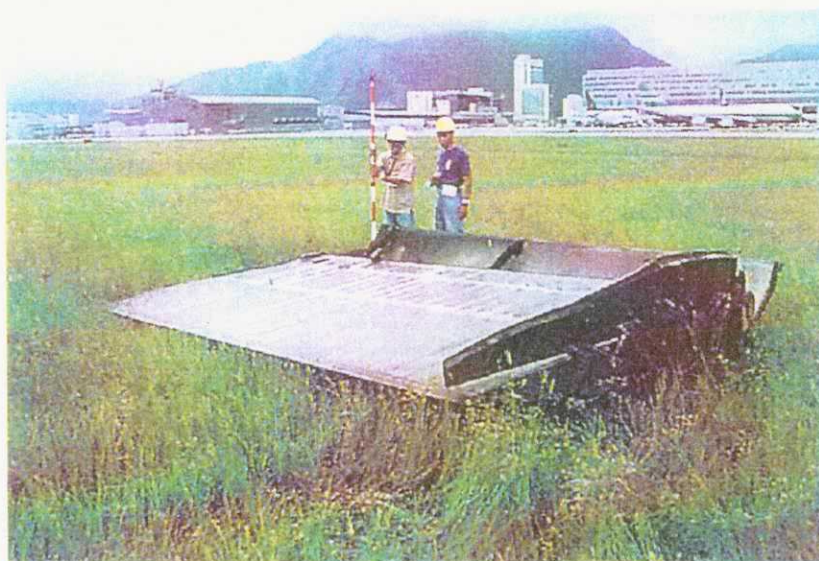
The China Airlines inboard flap was found off to the left of the runway and is thought to have been carried there by the crosswind (which was blowing right-to-left) after it departed the aircraft. The flap, as it was found, is pictured in Figure 15. The FedEx inboard flap was found on a taxiway to the right of the runway (Figure 16); note there was little or no crosswind present when the FedEx accident occurred.

Figure 15. Right Inboard Flap from Ship 518 (China Airlines)

It is viewed as significant that the lower surfaces of these flaps suffered no significant damage. The inboard flap would have been directly in the path of the main landing gear had the gear separated before the flap and would have been badly damaged. It is clear then, that the main landing gear did *not* "knock" the inboard flap off the aircraft.

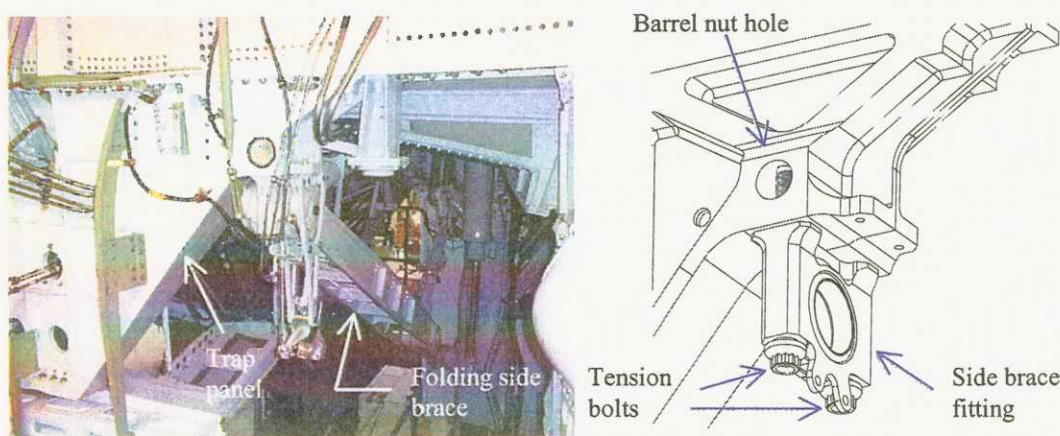
Figure 20. Side-brace-fitting-to-trap-panel joint (from inside the right wheel well)

The location of the side-brace-fitting-to-trap-panel (S-B-F-T-T-P) joint is highlighted in Figure 19. A photograph of a this area (taken from inside the landing gear wheel well) is included as Figure 20 along with a sketch of the joint (with the fixed and folding side braces removed).

The fixed brace and folding side brace are connected to one another and to the side brace fitting via a large pin. The side brace fitting is attached to the trap panel with two long tension bolts and mating barrel nuts. As discussed in Section 1.0 this joint is designed to take primarily vertical loads; the fore-and-aft and inboard/outboard loads are nominally small.

As was the case for the inboard flap's departure, the damage to the S-B-F-T-T-P joint was the result of large relative displacements between attach points on the wing and on the fuselage. After the right wing rear spar failed, the MLG-to-wing attach fitting moved up (relative to the fuselage) and the outboard wing twisted severely nose-down. This motion effectively tilted the truss formed by the MLG strut, and the fixed and folding side braces, and applied a nose-down twist to the S-B-F-T-T-P joint. This applied twist rocked the side brace fitting (bottom-end-aft) and resulted in "impressions" on the lower surface of the trap panel (Figure 21). Similar impressions were observed on the underside of the trap panel from the FedEx-Newark accident aircraft.

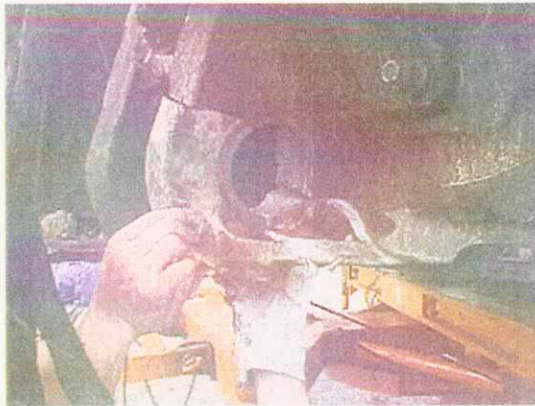
Figure 29. Wing fitting lugs that support the MLG forward trunnion [left]

In the case of the China Airlines accident the markings indicating contact between the right main landing gear strut and the wing attach fitting are slightly different (and not quite as clear). This is primarily due to the fact that the forward trunnion connection was partially failed (See Section 5.0) before the strut rotated outboard. The contact area for the forward trunnion was therefore very localized, and quickly resulted in the fracture of the remaining connection (the aft lug). See Figures 29 and 30. The two lugs that support the *aft* trunnion, the forwardmost still connected to a large piece of the wing fitting, also

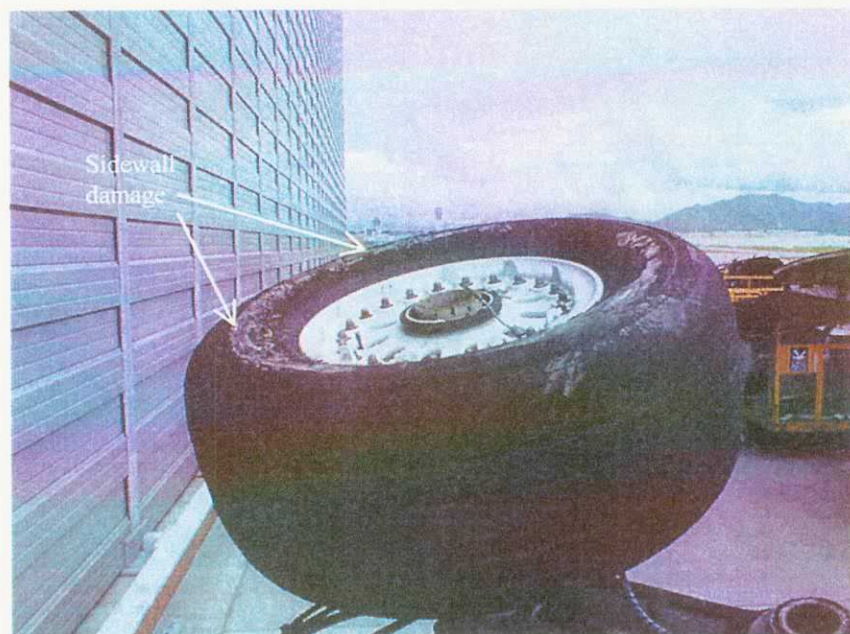
Substantial sidewall abrasion was noted on the inboard sidewall of the aft inboard tire on the right main landing gear truck (Figure 34). This evidence further supports the theory that the gear rotated outboard putting the inboard sidewalls of the inboard tires in contact with the ground.

Figure 34. Inboard aft tire from the right main landing gear

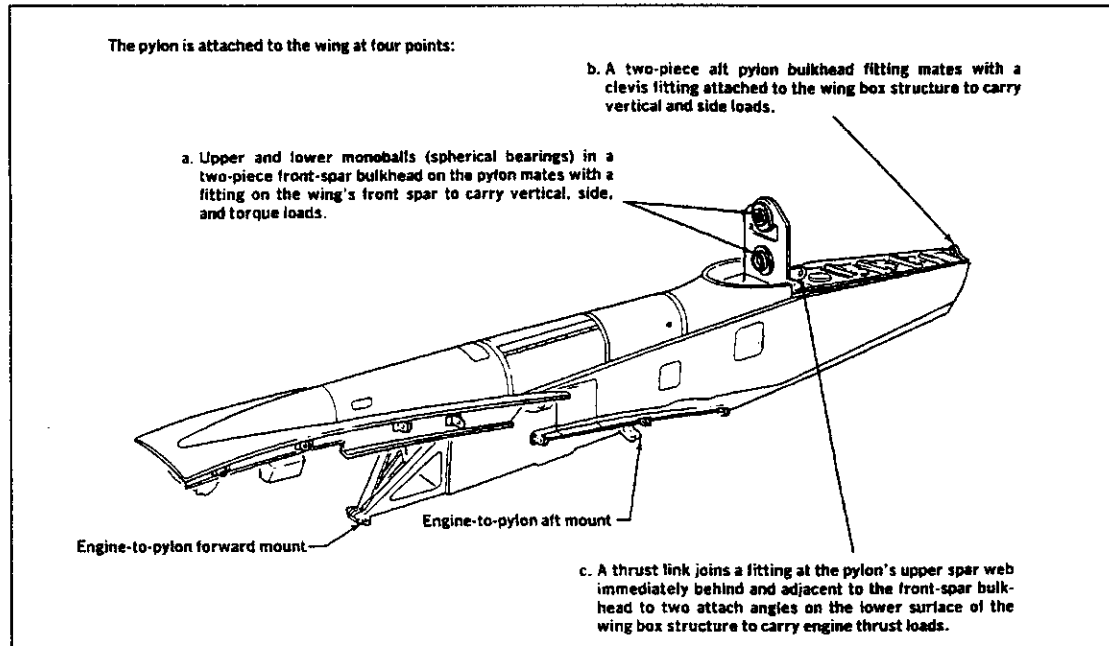
Figure 35. Pylon-to-wing attachment details

Figure 35 illustrates and describes the key elements of the attachment of the engine pylon to the wing. Figure 36 shows how the wing engine pylons are designed to “fuse” in the event of a wheels up landing to protect against rupture of the wing fuel tanks.

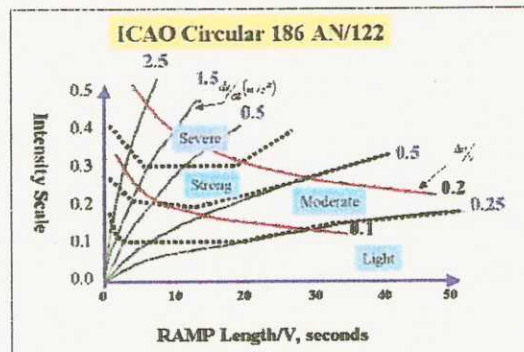
Figure 3: Wind Shear Intensity classification

In 1987, ICAO proposed a method to measure the wind shear hazard (ICAO, 1987). This method categorizes the wind shear into four levels: light, moderate, strong and severe. The wind shear identification depends on two parameters, i.e. the air speed change and the proportion of air speed, as shown in Figure 3.

Based on table 3 data for calculating wind shear intensity, the result showed CI642 encountered a strong to severe wind shear below 200 feet. The intensity of wind shear varied with radio altitude is plotted in figure 3.
